# COEUR D'ALENE WINDOW TEST REPORT

AAMA 613 EVALUATION OF ORGANIC COATING ON A PLASTIC PROFILE

J0098.01-106-31 R3

**Product:** Euro Bronze Organic coating on Energi vinyl extrusions

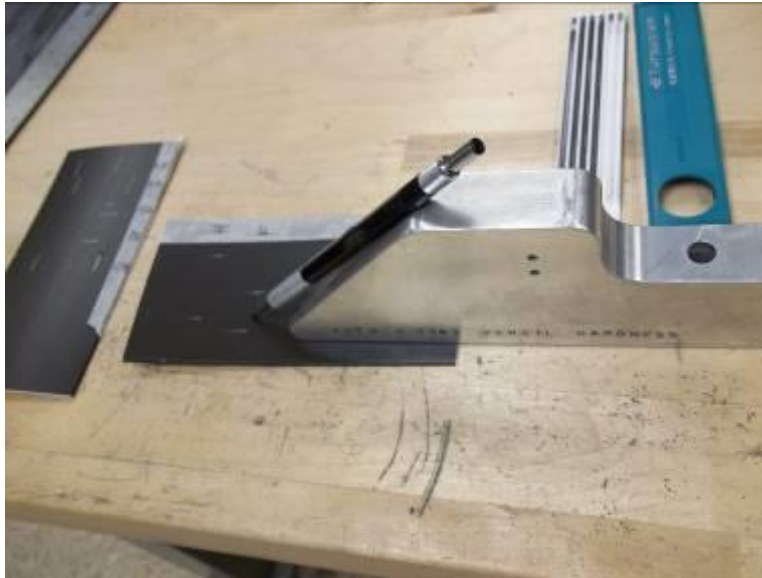
**Photo No. 3**

**Scratch Hardness and Cut Hardness Test In Progress**

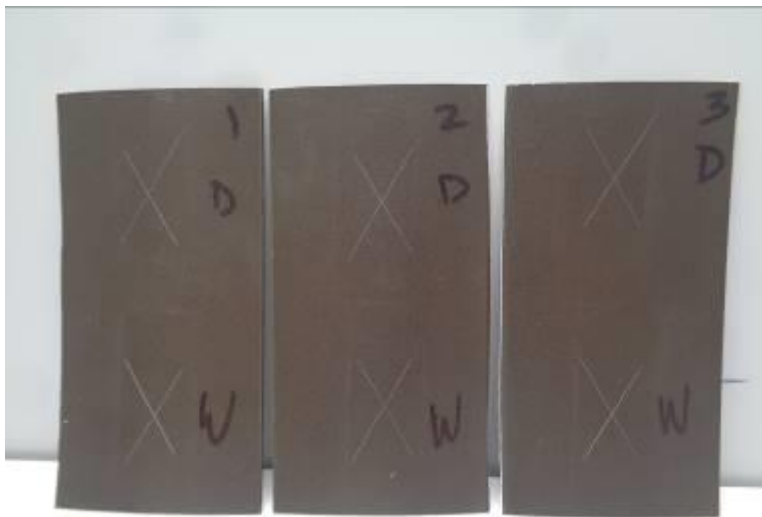
**Photo No. 4**

**Wet and Dry Adhesion Post Exposure Specimens Detail (Typical)**

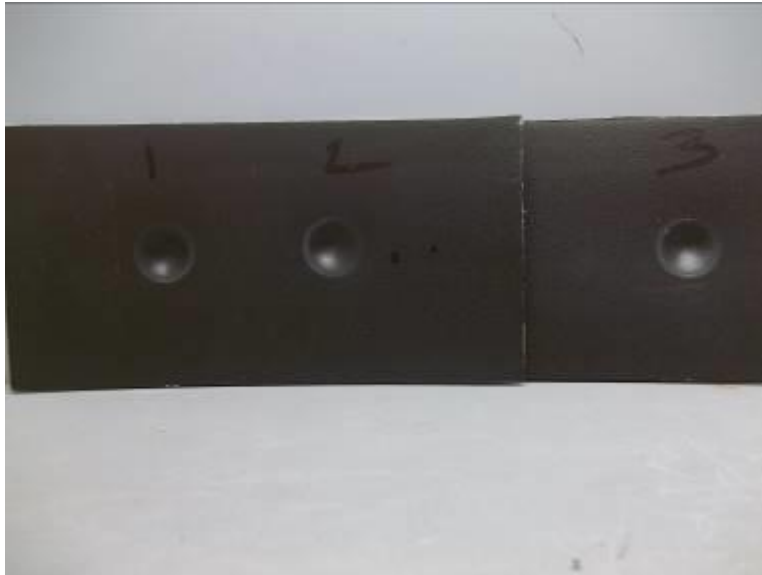
**Photo No. 5****Impact Resistance Specimens Post Adhesion Evaluation**

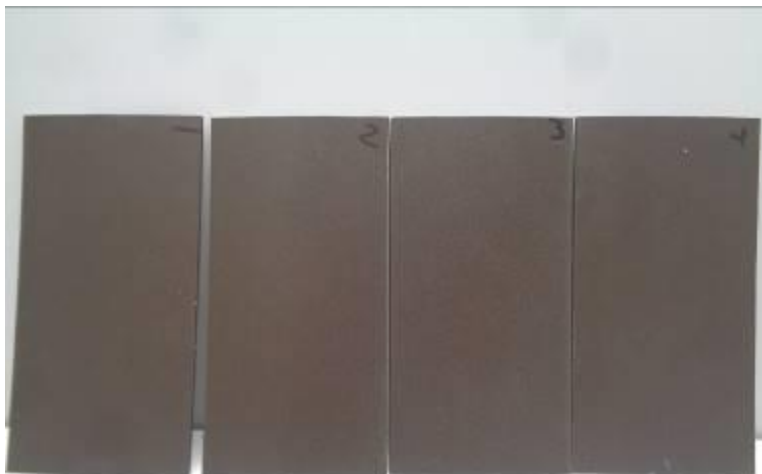
**Photo No. 6****Muriatic Acid Post Exposure Test Specimen Detail (Typical)**

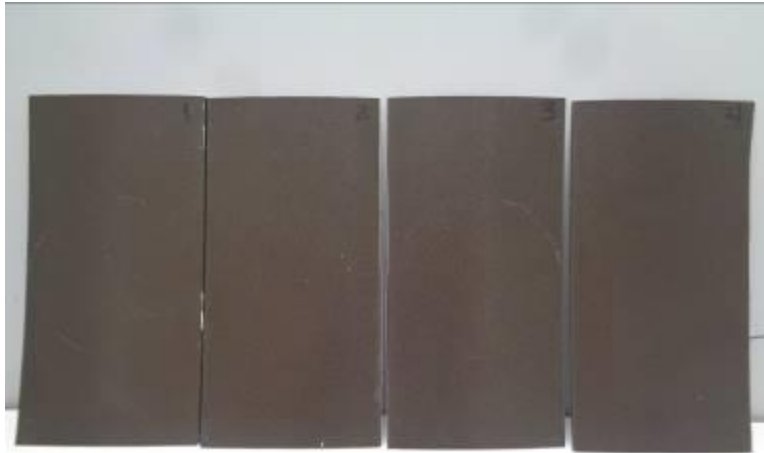
**Photo No. 7**

**Mortar Resistance Specimens Post Exposure Detail (Typical)**

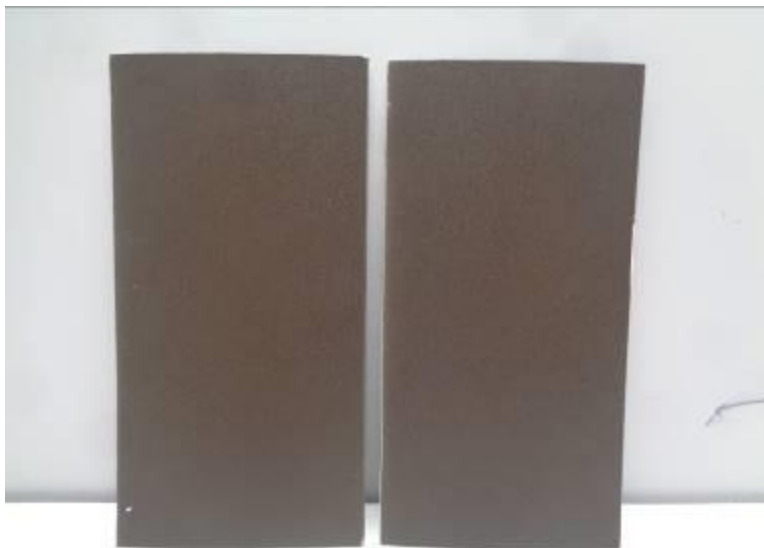
**Photo No. 8**

**Detergent Specimens Post Exposure Detail (Typical)**

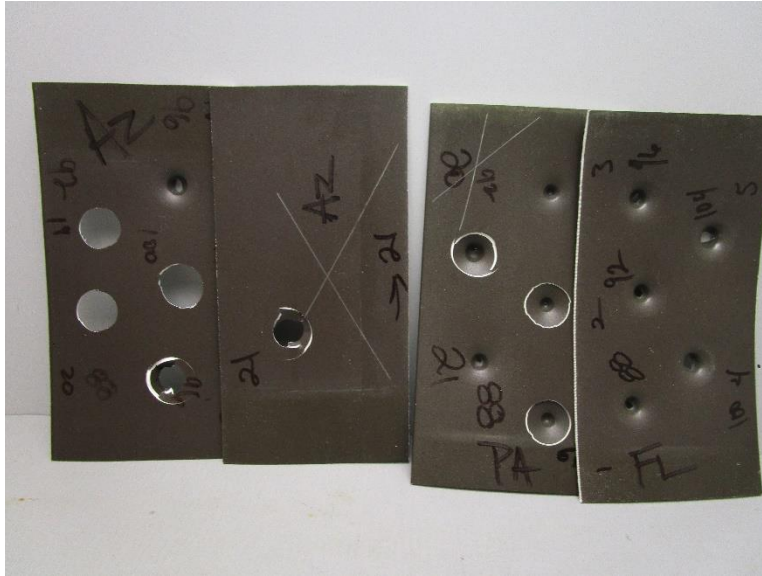
**Photo No. 13**

**12 Month Accelerated Weathering Post Impact Resistance; (Left) Arizona; (Center) Pennsylvania; (Right) Florida Detail (Typical)**

WEATHER EXPOSURE	RESULTS				REQUIREMENT
	LOCATION	IMPACT (in-lb/mil)	$\Delta E$ CHANGE	ADHESION LOSS CHECKING, OR CRACKING	
Initial	PA	1.3	N/A	None	Minimum impact of 5340 J/m (1.2 in-lb/mil)
6-Month	PA	1.7	0.20	None	Minimum impact of 2670 J/m (0.60 in-lb/mil), $\Delta E \leq 5$ , and show no checking, cracking or loss of adhesion after taping and only slight chalking
	FL	0.90	0.26	None	
	AZ	1.3	0.37	None	
12-Month	PA	1.2	0.42	None	
	FL	1.2	0.67	None	
	AZ	1.2	0.69	None	
24-Month	PA	1.1	0.64	None	
	FL	1.3	0.99	None	
	AZ	1.2	1.02	None
