Capillary Tubes & Breather Tubes

Capillary Tube vs. Breather Tubes

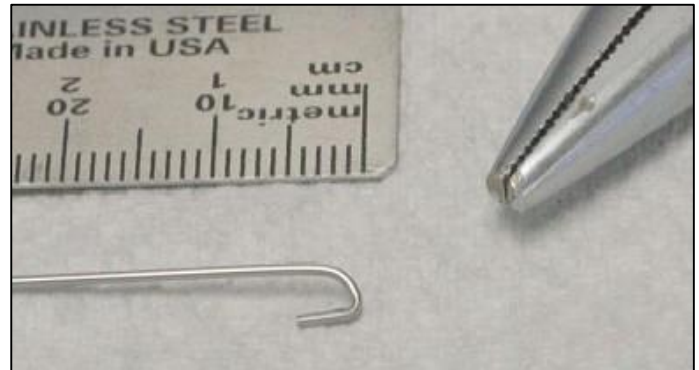
Fig1 A capillary tube prior to insertion into the spacer

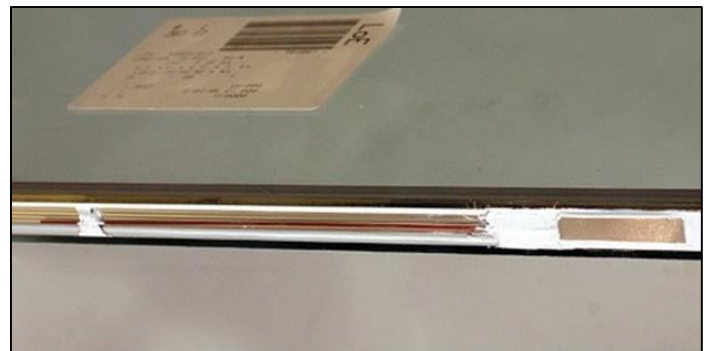
Fig 2 An installed capillary tube, colored red for photo only
